# Manhole Inspection Summary

Manhole # S2100\_014MH

Insp Date: **7/10/07 8:57 AM**

**Location** Address: **2200 OREM-RUSKIN**

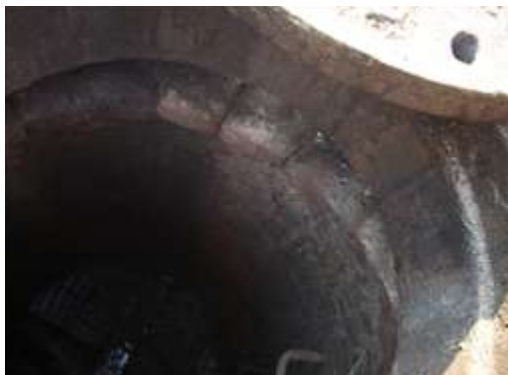
Defect 1

DEBRIS ON BENCH

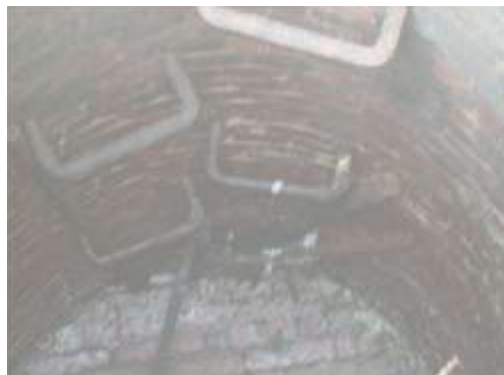
Defect 4

**Frame** Offset: **3** (in.) Condition: ☒ Sound ☐ Cracked ☐ Leaks

FRAME OFFSET

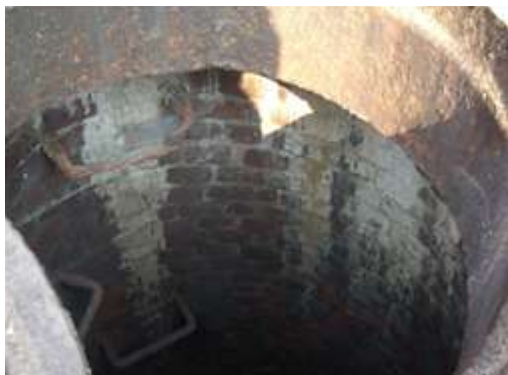
Defect 3

**Surcharge** ☒ Evidence Of Surcharge Depth: **6** (ft.) ☐ Active Surcharge Present

SURCHARGE EVIDENCE ON STEPS.

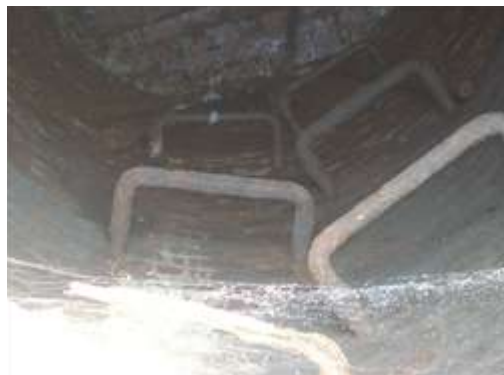
Defect 2

Infiltration: ☐ None ☐ Joint ☐ Cracks ☐ Mortar ☐ Roots ☒ Wall

INFILTRATION OF CORBEL

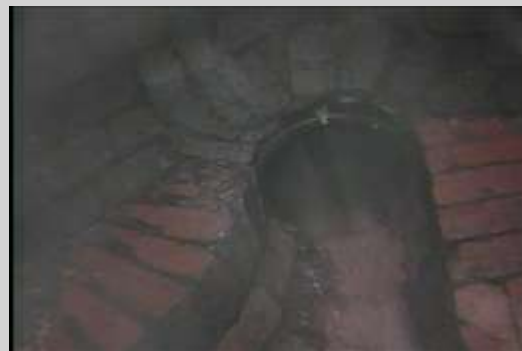
Drop In @ 3 O'Clock

SURCHARGE EVIDENCE ON STEPS

Drop: **Outside** Rod and Bar  
Angled: **Yes** Reading: **10.21** (ft.)  
Inv Depth: **11.21** (ft.)

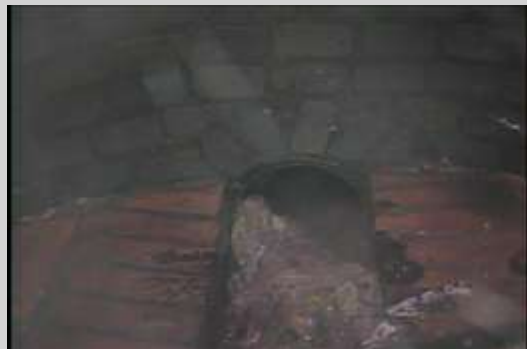
6 O'Clock Inflow

Deposits: ☐ None ☐ Mud ☒ **Sludge** ☐ Debris ☐ Grease

Silt Depth: **5** (in.) Deposits Extent: **Medium**
